# SERVICE BULLETIN 239350

PER NAVISTAR TSI 03-12-12 OF AUGUST, 2003

Service radiator support rods for 2000, 5000, and 9000 model series.

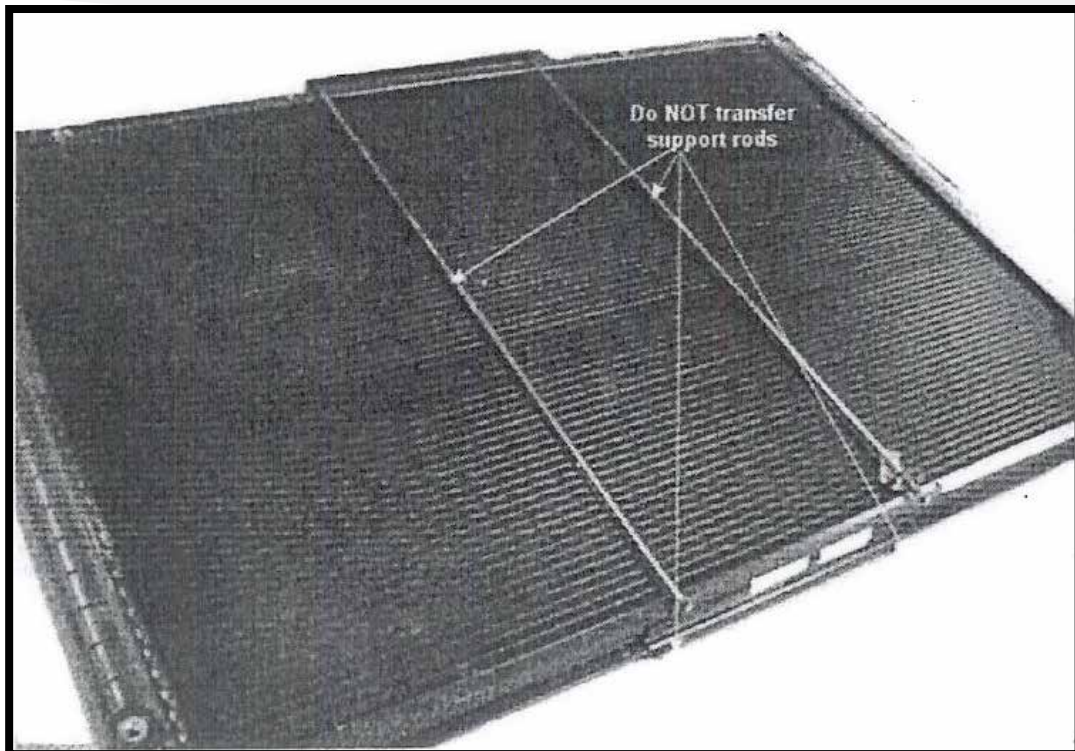
The service part radiator is now aluminum instead of copper brass. The core has been changed to aluminum in order to accommodate the higher horsepower applications. On the copper brass radiator there are two support rods on the front and back sides of the radiator that run from top of the radiator to the bottom for added strength. (See Photo) The aluminum radiators do not require these four support rods so DO NOT attempt to transfer the support rods from the old radiator to the new radiator. Doing so will cause interference in mounting.

When installing the aluminum radiator **IT IS IMPORTANT TO REPLACE THE FOUR RUBBER ISOLATORS** that go between the radiator and the frame.
